# Manhole Inspection Summary

Manhole # S29I\_\_017MH

Insp Date: **9/23/08 8:09 AM**

**Location** Address: **694 Penn St**

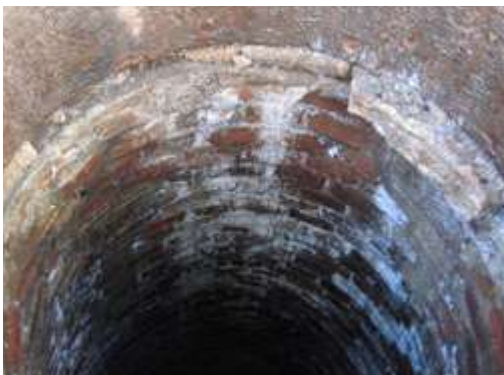
Defect 1

Condition: ☐ Sound ☐ Cracked ☒ **Leaks**

Condition: ☐ Sound ☐ Cracked ☐ Root Intrusion ☒ **Loose Brick** ☐ Deteriorated

lid/frame infiltration, loose bricks in chimney

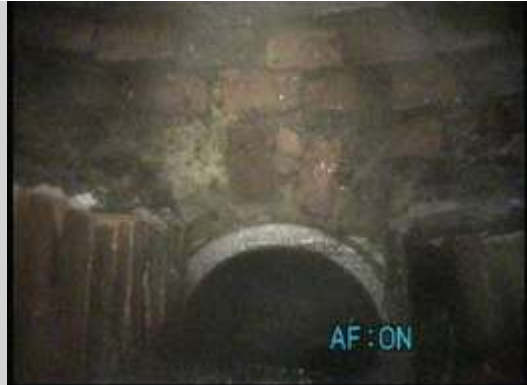
12 O'Clock Outflow

Pipe Height: **10.8** (in.) Rod and Bar (Angled)  
Pipe Material: **Clay** ☐ Pipe Lined  
Invert Depth: **11.12** (ft.) Flow Characteristics: **Fast**  
Deposits: ☒ None ☐ Mud ☐ Sludge ☐ Debris ☐ Grease  
Silt Depth: **0** (in.) Deposits Extent:  
Infiltration: **None** Pipe Seal Cond: **Sound**

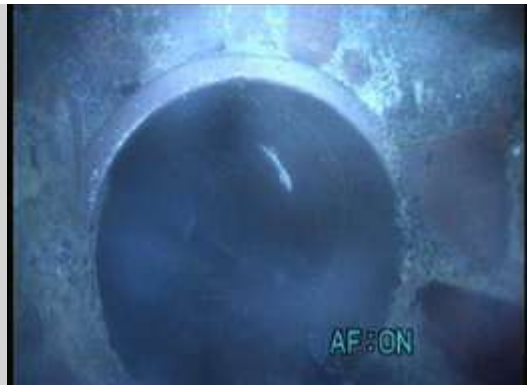
4 O'Clock Inflow

Pipe Height: **10.8** (in.) Rod and Bar (Angled)  
Pipe Material: **Clay** ☐ Pipe Lined  
Invert Depth: **10.75** (ft.) Flow Characteristics: **Slow**  
Deposits: ☒ None ☐ Mud ☐ Sludge ☐ Debris ☐ Grease  
Silt Depth: **0** (in.) Deposits Extent:  
Infiltration: **None** Pipe Seal Cond: **Sound**

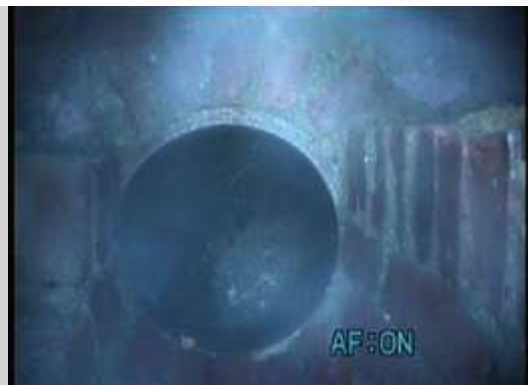
6 O'Clock Inflow

Infiltration: **None** Pipe Seal Cond: **Sound**
